Station Master's House: Restoration

McGurk Architects

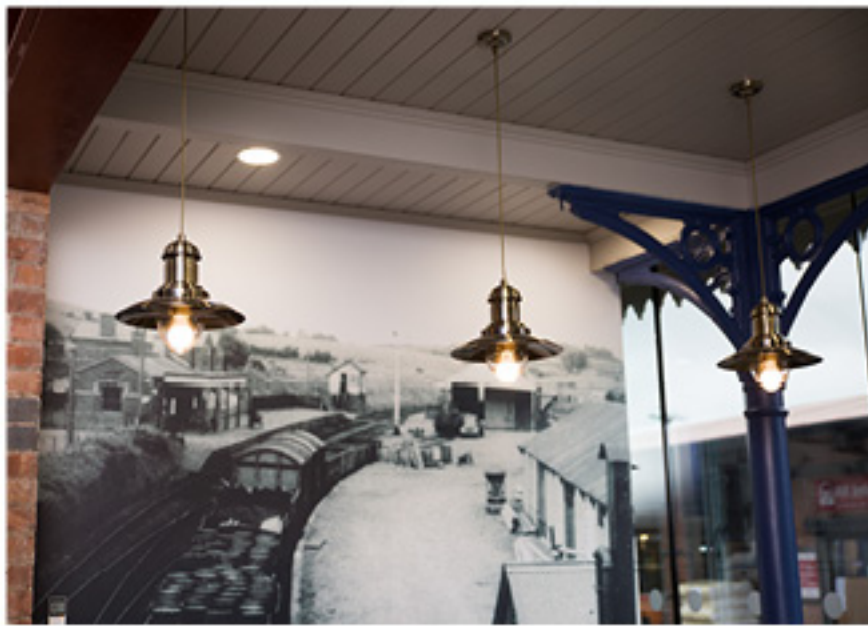
ornate cast iron engraved support columns and the original brick building behind.

traditional building skills and traditional design. Enclosing the existing canopy allowed us to utilise this area to provide additional internal usable space for the client whilst also defining the entrance to the building with the new approach from Station Road. The space under the canopy was converted into a waiting and reception area; recalling its historic usage as a waiting platform. The frameless glazing system reveals the
